Project 681722.00
9 November 2020
R.001.docx
SDH:BWE

Geotechnical Inspections and Testing
Proposed Subdivision
Release 14, Harmony Estate

This report presents the results of the inspection and testing of bulk earthworks for Release 14 as part of the Harmony Subdivision at Palmview. The work was undertaken at the request of Shadfroths Civil Pty Ltd.

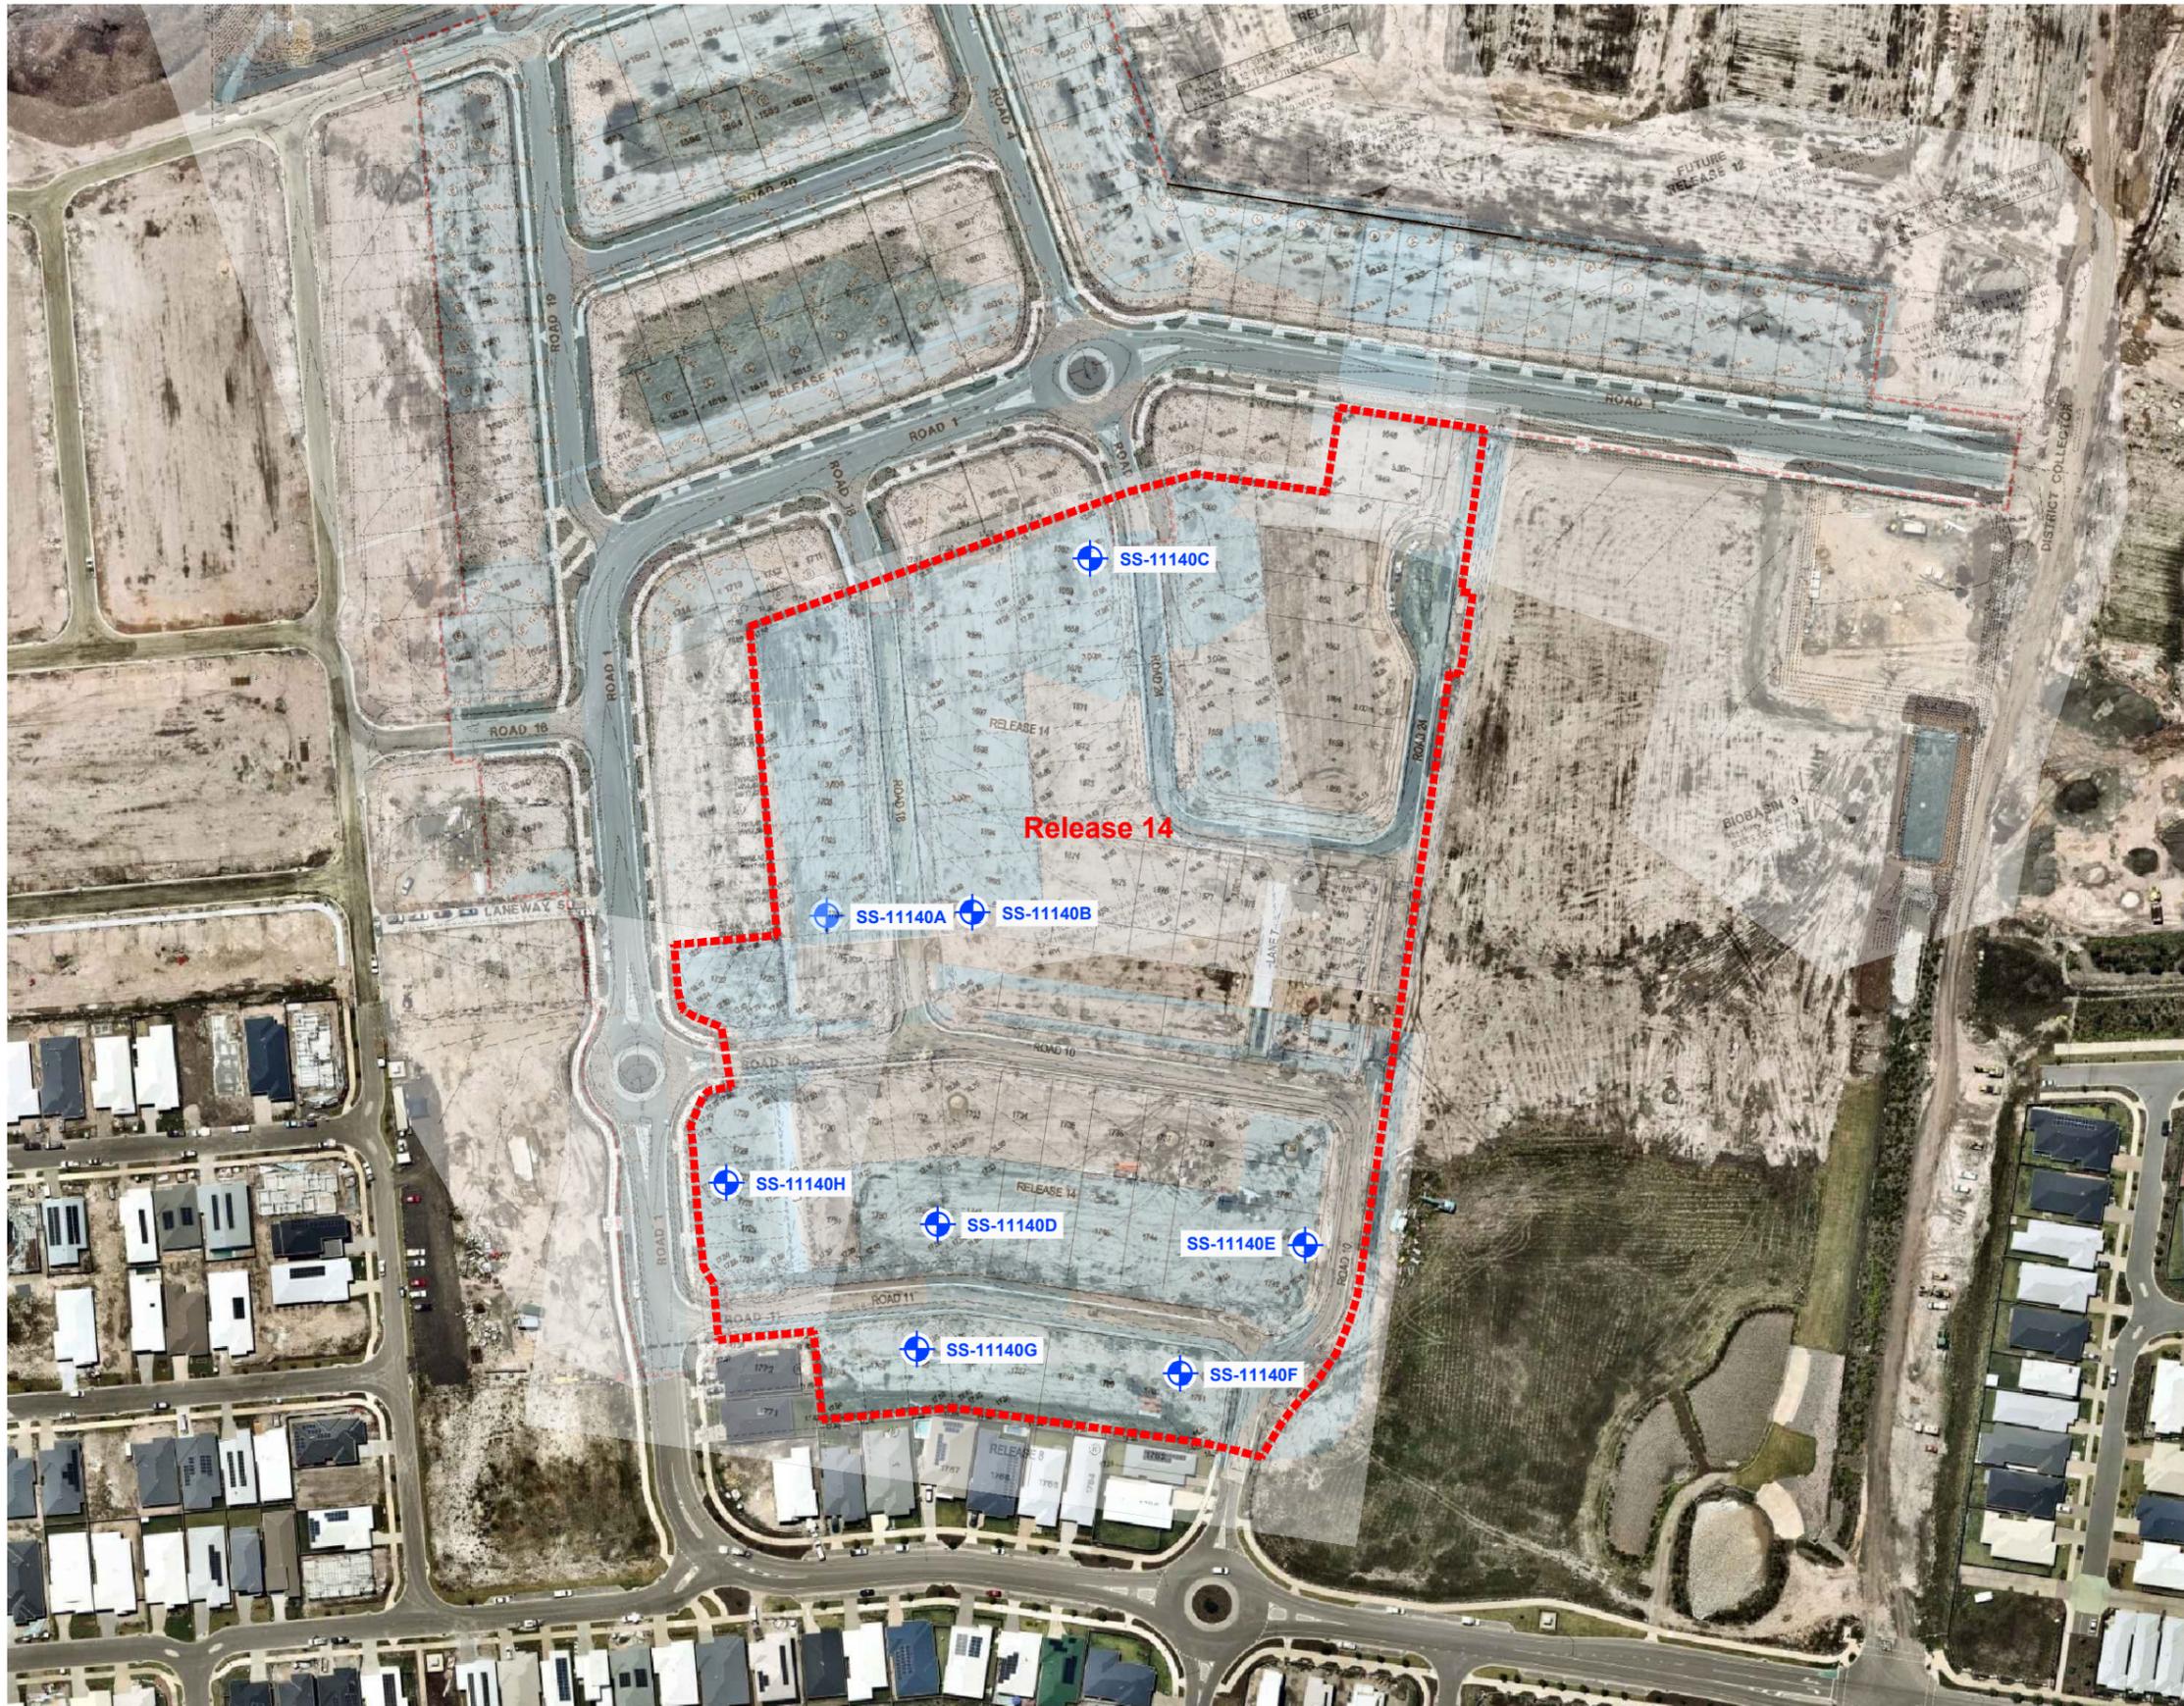
Location Plan

The extent of filling placed at the development over the period 14 August 2020 to 5 November 2020, as covered by this report is shown by the test locations (including elevation) noted on the test report sheets and test location plan attached to this report. Level 1 certification covers Lots 1657, 1658, 1660-1662, 1667-1670, 1682-1710, 1723-1729, 1739-1750 and 1753-1761. Any other part of the site is not covered by this report unless stated otherwise.
